**State of Louisiana
Coastal Protection and Restoration Authority**

2015 Annual Inspection Report

Jonathan Davis Wetland Protection

State Project Number BA-20
Priority Project List 2

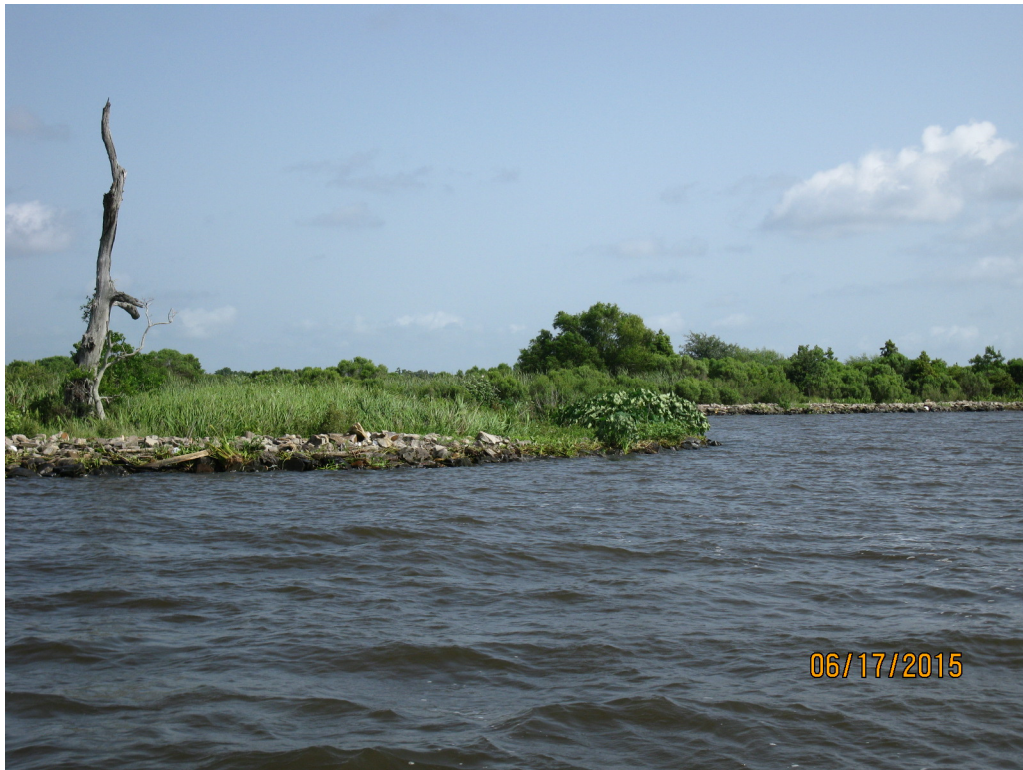
Photo #1 – Bayou Perot Shoreline Protection (CU3)

No significant changes were noted since the last inspection. The rock shoreline protection appeared to be in good condition, with minor settlement in some areas. The areas of lower elevation deserve continued observation on future inspections, but no maintenance needs were identified at this time.

Item	Condition	Physical Damage	Corrosion	Photo #	Observations and Remarks
Signage and supports	Good				
Armored plug	Good				
Rock Dike	Good; see remarks			1	Minor settlement observed in some areas, no repairs needed at this time.
Earthen Embankment	Good				
Construction Unit No.3 Structure Description: The rock dike consist of 13,088 linear ft. of rock dike with a 6 ft. top width and a crest elevation of +3.5 ft. The shoreline stabilization extends from Site 12 west to the Gulf Intracoastal Waterway

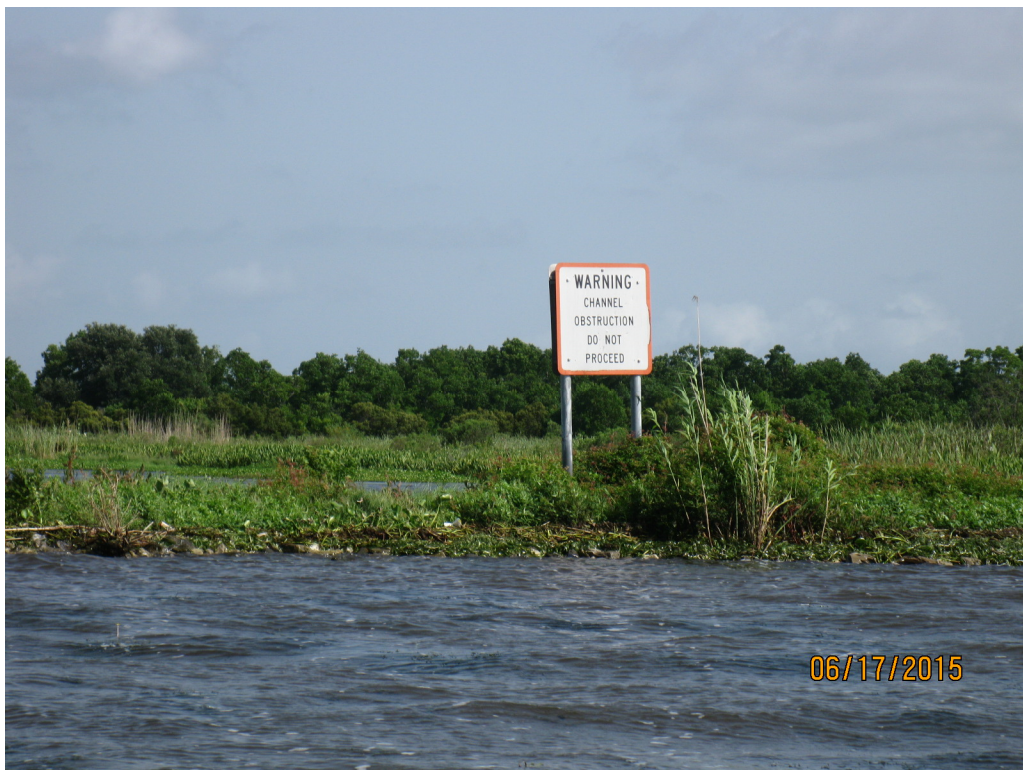
Photo #2 – Structure No. 12

Minor settlement has occurred, but the structure is in good condition. No maintenance needs were identified at this location.

Item	Condition	Physical Damage	Corrosion	Photo #	Observations and Remarks
Signage and supports	Good			2	
Armored plug	Good			2	No change since last inspection; maintenance not required at this time.
Earthen Embankment	Good				
Construction Unit No.1 Structure Description: 294 linear ft. rock rip-rap armored rock-filled plug located in a pipeline channel north of Bayou Perot, west of Bayou Barataria, and east of the GIWW. The crest of the weir was set at an elevation of +3.9 ft. NGVD. The rock-filled plug contains 2,689 tons of rock filled with 2,518 tons of rip-rap armor. Aluminum warning signs are also located in the rock embankment.

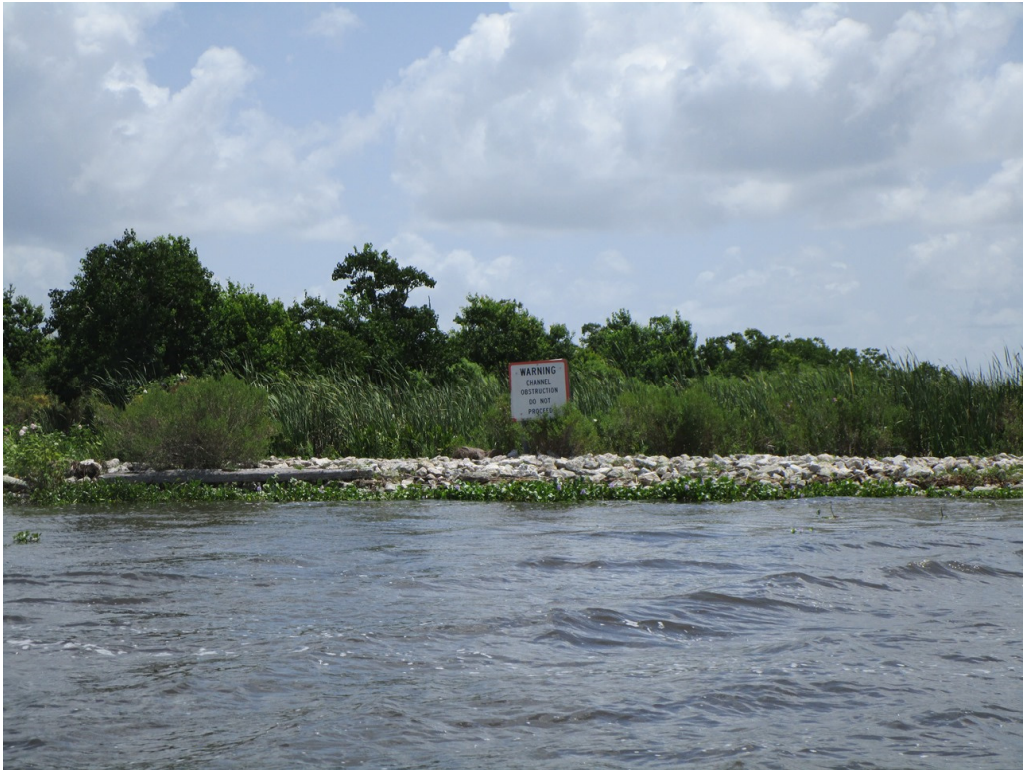
Photo #3 – Structure #15

Weir was converted to a rock plug structure as part of the work effort for Construction Unit 4. No defects were noted during the inspection.

Item	Condition	Pysical Damage	Corrosion	Photo #	Observations and Remarks
Signage and supports	Good			3	
Armored Plug	Good			3	This structure was converted into a channel plug as part of the completed CU4 maintenance work.
Earthen Embankment	Good				
Construction Unit No.1 Structure Description: 132 linear ft. of rock rip-rap armored weir with a 50 ft. wide boat bay located in a pipeline channel north of Bayou Perot, west of Bayou Barataria and east of the GIWW and Site 14. The crest of the rock weir was constructed to an elevation of +4.0 ft. NGVD. The invert of the boat bay is at and elevation of -3.0 ft. The rock filled weir contains 1,248 tons of rock fill with and 728 tons of rock rip-rap armor. Two (2) aluminum warning signs are located through the rock armored embankment on each side of the boat bay.

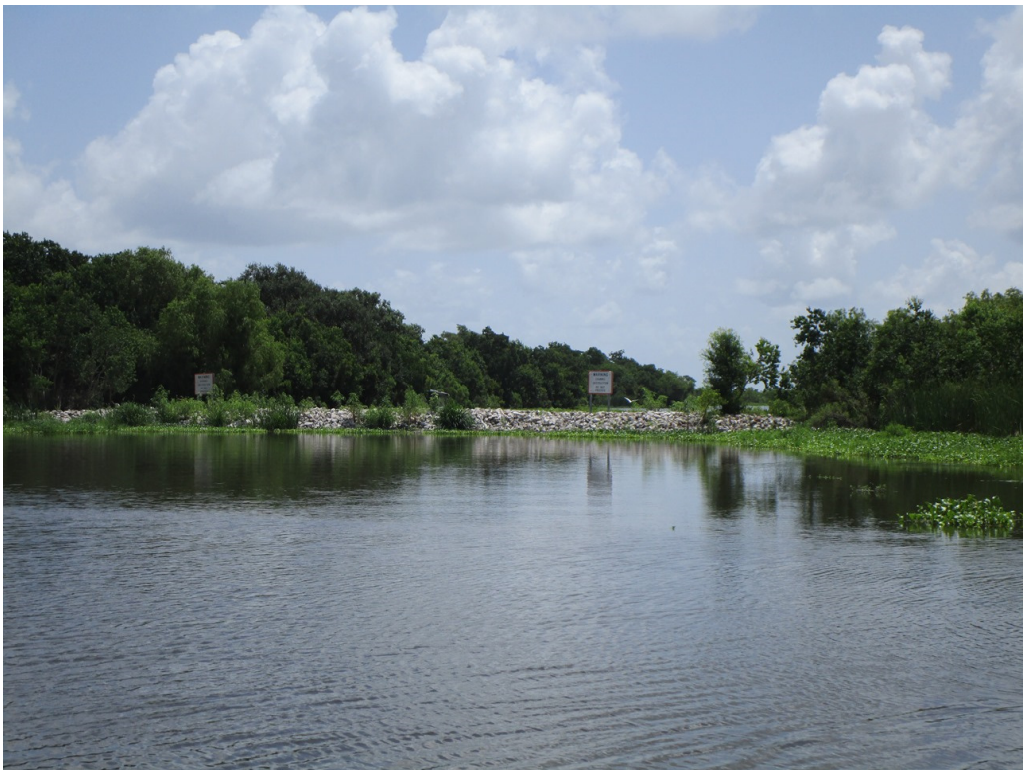
Photo #4 – Structure #16

Rip-rap and warning signs appeared to be in good condition. No immediate maintenance requirements were identified at this structure.

Item	Condition	Physical Damage	Corrosion	Photo #	Observations and Remarks
Signage and supports	Good			4	
Armored Plug	Fair			4	No maintenance needs identified at this time.
Earthen Embankment	Good				
Construction Unit No.1 303 linear ft. of rock rip-rap armored rock filled plug located in a pipeline channel north of Bayou Perot, west of Bayou Barataria, east of the GIWW and Site 15. The crest of the plug was constructed to an elevation of +4.0 ft. NGVD. The rock filled plug contains 6,483 tons of rock fill and 1,766 tons of rock rip-rap armor. Two (2) aluminum warning signs are located through the rock plug embankment.

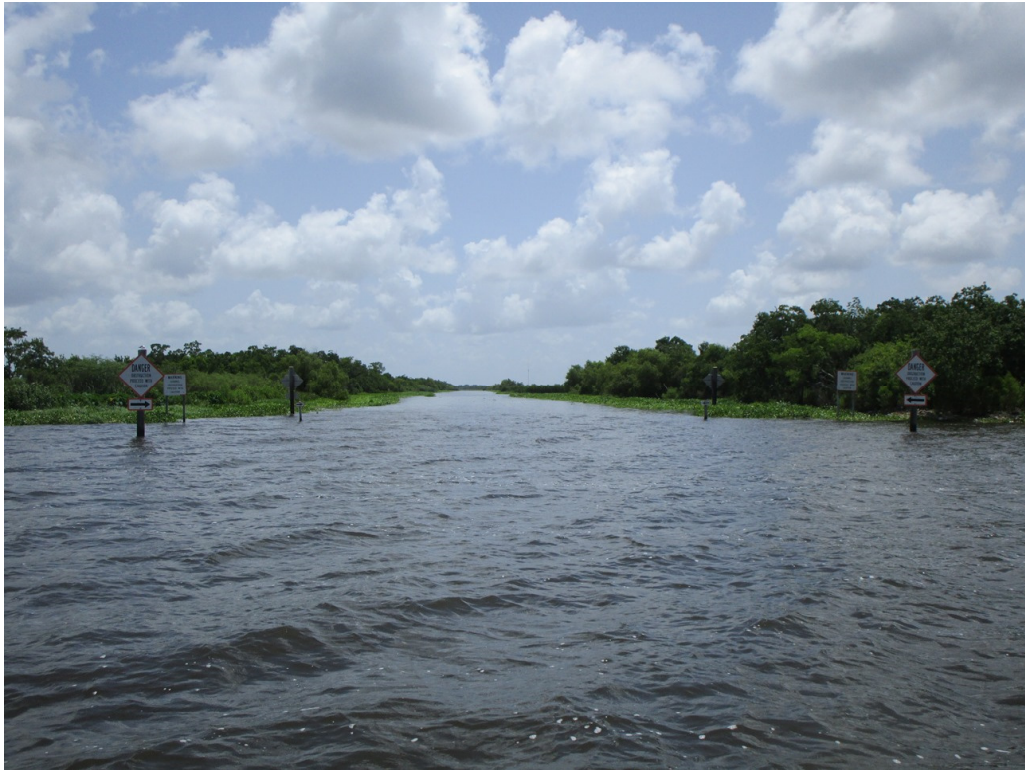
Photo #5 – Structure #19

Weir has experienced some settlement, but is performing as designed. Warning signs and timber supports were in good condition. No maintenance is required at this time.

Item	Condition	Physical Damage	Corrosion	Photo #	Observations and Remarks
Signage and supports	Good			5	
Armored Weir	Good			5	No change since last inspection; no maintenance needs were identified.
Earthen Embankment	Good				
Construction Unit No.1 Structure Description: 239 linear ft. of rock rip-rap armored rock filled fixed crest weir with a 60 ft. wide boat bay located in a pipeline channel east of the GIWW, north of Bayou Perot, and west of Bayou Barataria. The crest of the weir was constructed to an elevation of +1.9 ft. NGVD on the north side and +2.0 ft. NGVD on the south. The boat bay invert was constructed to an elevation of -2.5 ft. NGVD. The rock filled plug contains 1,014 tons of rock fill with 572 tons of rock rip-rap armor. Aluminum warning signs are located on each side of the boat bay through the rock embankment.

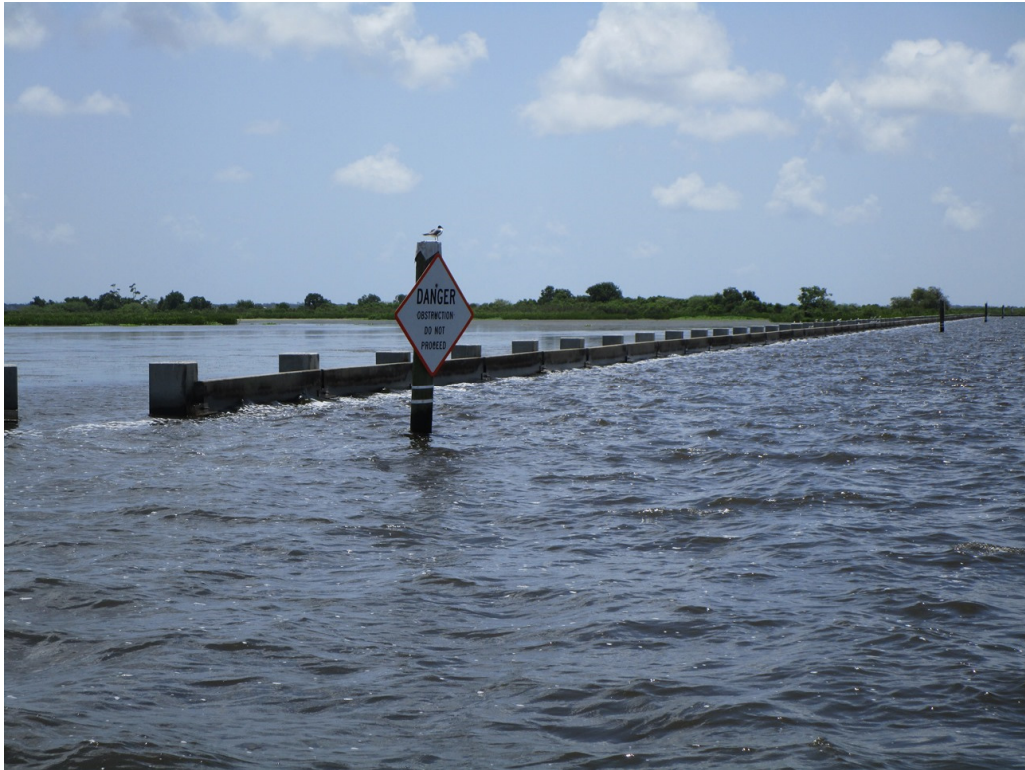
Photo #7 – Panel Wall Shoreline Protection (CU4)

No defects in the concrete panel wall sections were noted; the structure appeared to be in good condition. Minor damage/vandalism to some warning signs was noted, but all signs

and timber supports are in place and performing as designed. No immediate maintenance needs were identified at this construction unit.

Item	Condition	Physical Damage	Corrosion	Photo #	Observations and Remarks
Signage and supports	Good	Minor; see remarks		7	Some fading noted, minor spray-paint vandalism to border of one sign was observed. Sign faces and text were legible; no repairs needed at this time.
Concrete wall panels, piles, hardware	Good			7	No defects noted; structure was performing as designed.
Rock Dike	Good			6	No defects noted; structure was performing as designed.
Construction Unit No.4 Structure Description: The wall consists of approx. 12,850 linear ft. of pre-cast concrete wall sections supported by 848 pre-cast concrete piles, in addition to approx. 4,290 linear feet of rock rip-rap bank stabilization/shoreline protection. C.U. #4 extends across the northern edge of Bayou Rigolettes and Bayou Perot, from just east of Structure #12 to Structure #20.

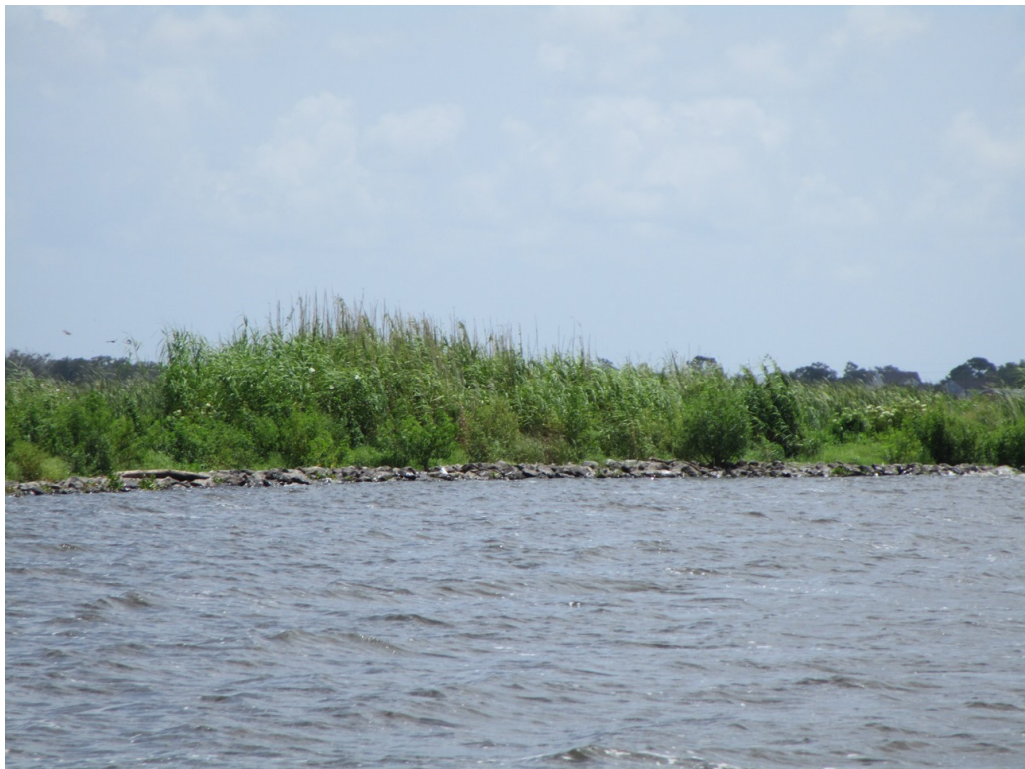
Photo #8 – Bayou Rigolettes Shoreline Protection (CU2)

The rock appears to be in good condition. Minor settlement was observed near the western end of this feature, but the shoreline protection function was being adequately performed. This area should be monitored on future inspections, but no immediate maintenance will be required.

Item	Condition	Physical Damage	Corrosion	Photo #	Observations and Remarks
Signage and supports	Good				
Armored plug	Good				
Rock Dike	Good; see remarks			8	Minor settlement observed in some areas, no repairs needed at this time.
Earthen Embankment	Good				
Construction Unit No.2 Structure Description: The rock dike consist of 3,967 linear ft. of rock dike with a 6 ft. top width and a crest elevation of +3.5 ft. The shoreline stabilization extends from Site 22A west to Structure No.20.
